Atlanta Inbuilt

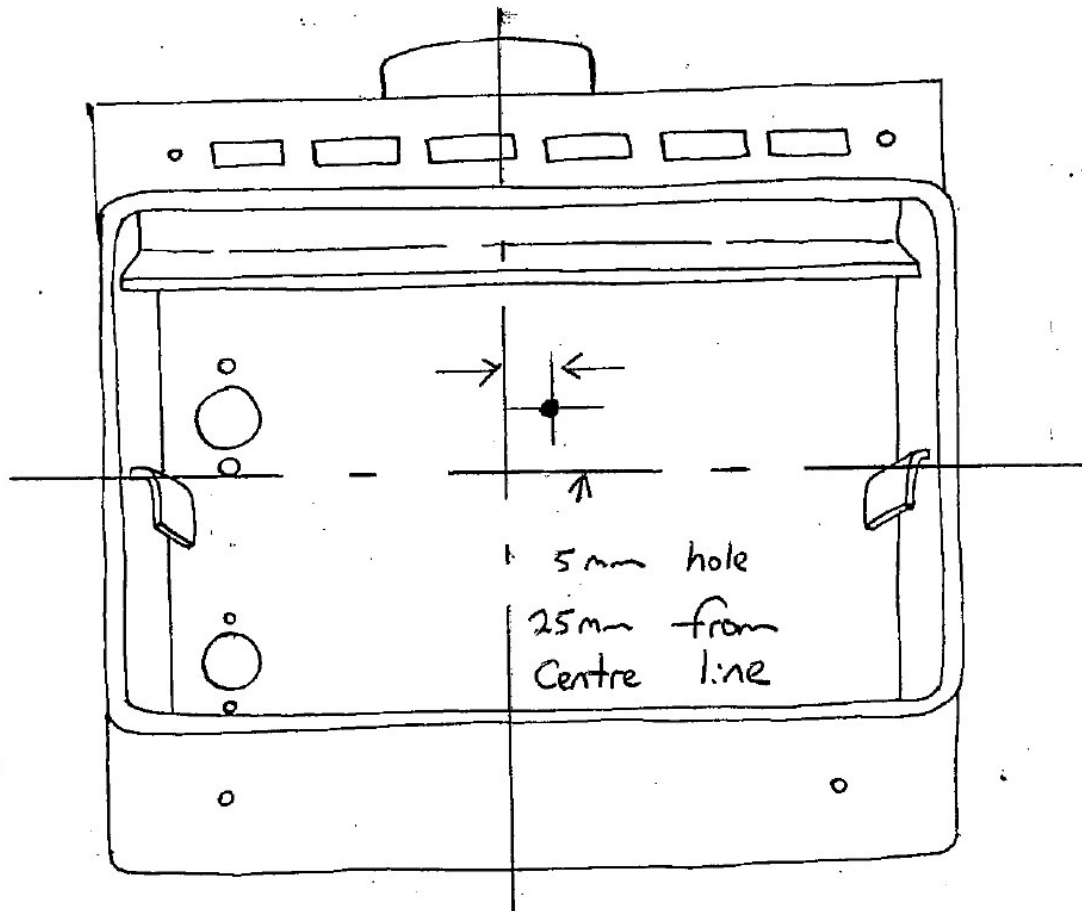
If the firebox is producing large banging noises on the heat up and the cool down, this is caused by the outer rear cabinet panel convexing out on heating up then returning back to position. This requires the rear panel to be held in the convex position.

Drill a 5mm hole in the rear of the firebox as shown, tap with a 6mm tap and fully wind in the 6m x 50 bolt provided.

Drill 25mm from the centre to miss the rear ribs on the firebox at height just under the baffle.
